# New Ignition Mechanism in Oxygen-enriched Environment: Spontaneous Combustion

After a fire occurred overseas in an Expeditionary Deployable Oxygen Concentration System (EDOCS) unit used by the U.S. Air Force, the NASA Johnson Space Center's White Sands Test Facility (WSTF) Oxygen Group was requested to perform a failure analysis to determine the fire's cause. The EDOCS is a portable oxygen concentration system used to supply concentrated oxygen for medical purposes.

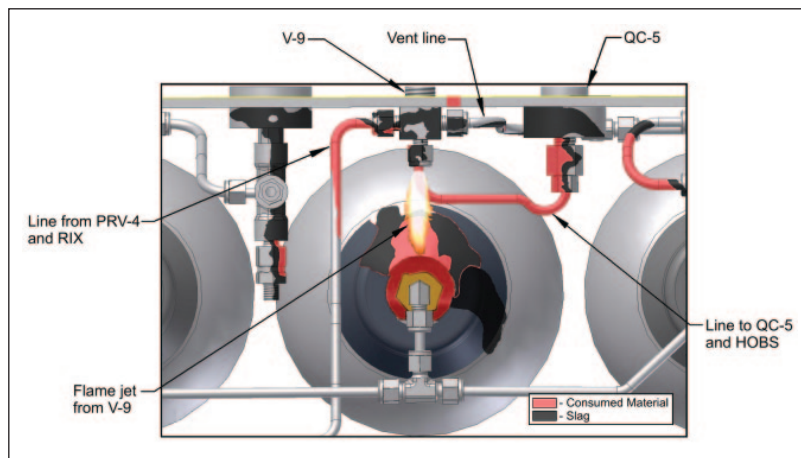
Fig. 1. Flame jet from V-9 impinging on carbon steel cylinder u-bolt and cap.

In the EDOCS fire, it is surmised that cellulose particles accumulated between the PTFE seat capsule packing and the stainless steel seat or ball and reached the critical diameter that would cause spontaneous ignition of the particles. It is postulated that the burning cellulose particles ignited the PTFE seat packing and burned downstream to the edge of the stainless steel seat or ball. As the flame impinged the sharp corner of the stainless steel seat or ball, it was ignited (Location A in figure 3). The burning proceeded downstream, out of V-9, into the connecting stainless steel tube and out through the 90-deg bend, producing the flame jet seen in figure 1.

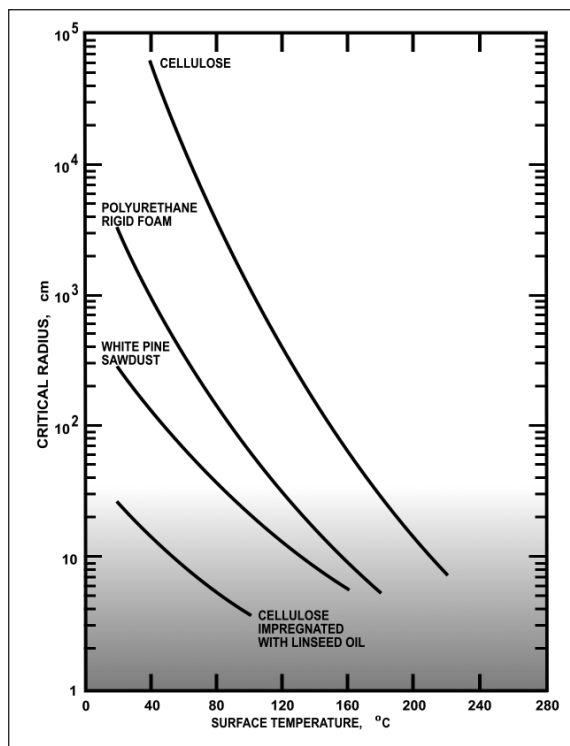
Fig. 2. Critical radius of oil-soaked cellulose particles as a function of surface temperature in air.

The autoignition temperature of an accumulation of cellulose fibers and particles is dramatically affected by the radius of the deposit of particles. Oil-impregnated cellulose will ignite in air at 100°C (212°F) if the radius of the accumulated deposit of particles reaches 4 cm (1.6 in.) (figure 2). If it is assumed that the critical diameter decreases directly as a function of the oxygen concentration, then the critical radius in 95% oxygen at 2200 psi would be  $[4 \text{ cm} \times (14.7 \text{ psi}/2200 \text{ psi}) \times (21\% \text{ oxygen}/95\% \text{ oxygen}) = ] 0.006 \text{ cm}$  (0.002 in.). In addition, it is observed that if the diameter of the accumulated deposit of cellulose particles is increased to  $[27 \text{ cm} \times (14.7 \text{ psi}/2200 \text{ psi}) \times (21\% \text{ oxygen}/95\% \text{ oxygen}) = ] 0.04 \text{ cm}$  (0.016 in.), then the autoignition temperature of the oil-soaked cellulose is 20°C (68°F).

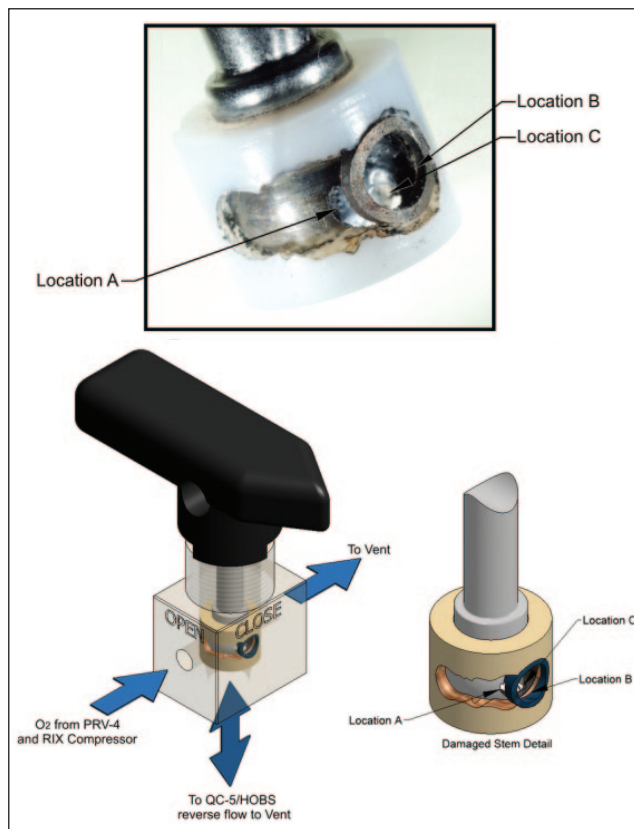
**Fig. 3.** Damaged stainless steel valve stem/polytetrafluorethylene capsule seat packing from V-9. (See Location A.)
